The Liberty Wheel project: Part 1: The way we were

Andrea Bracciali – Gianluca Megna

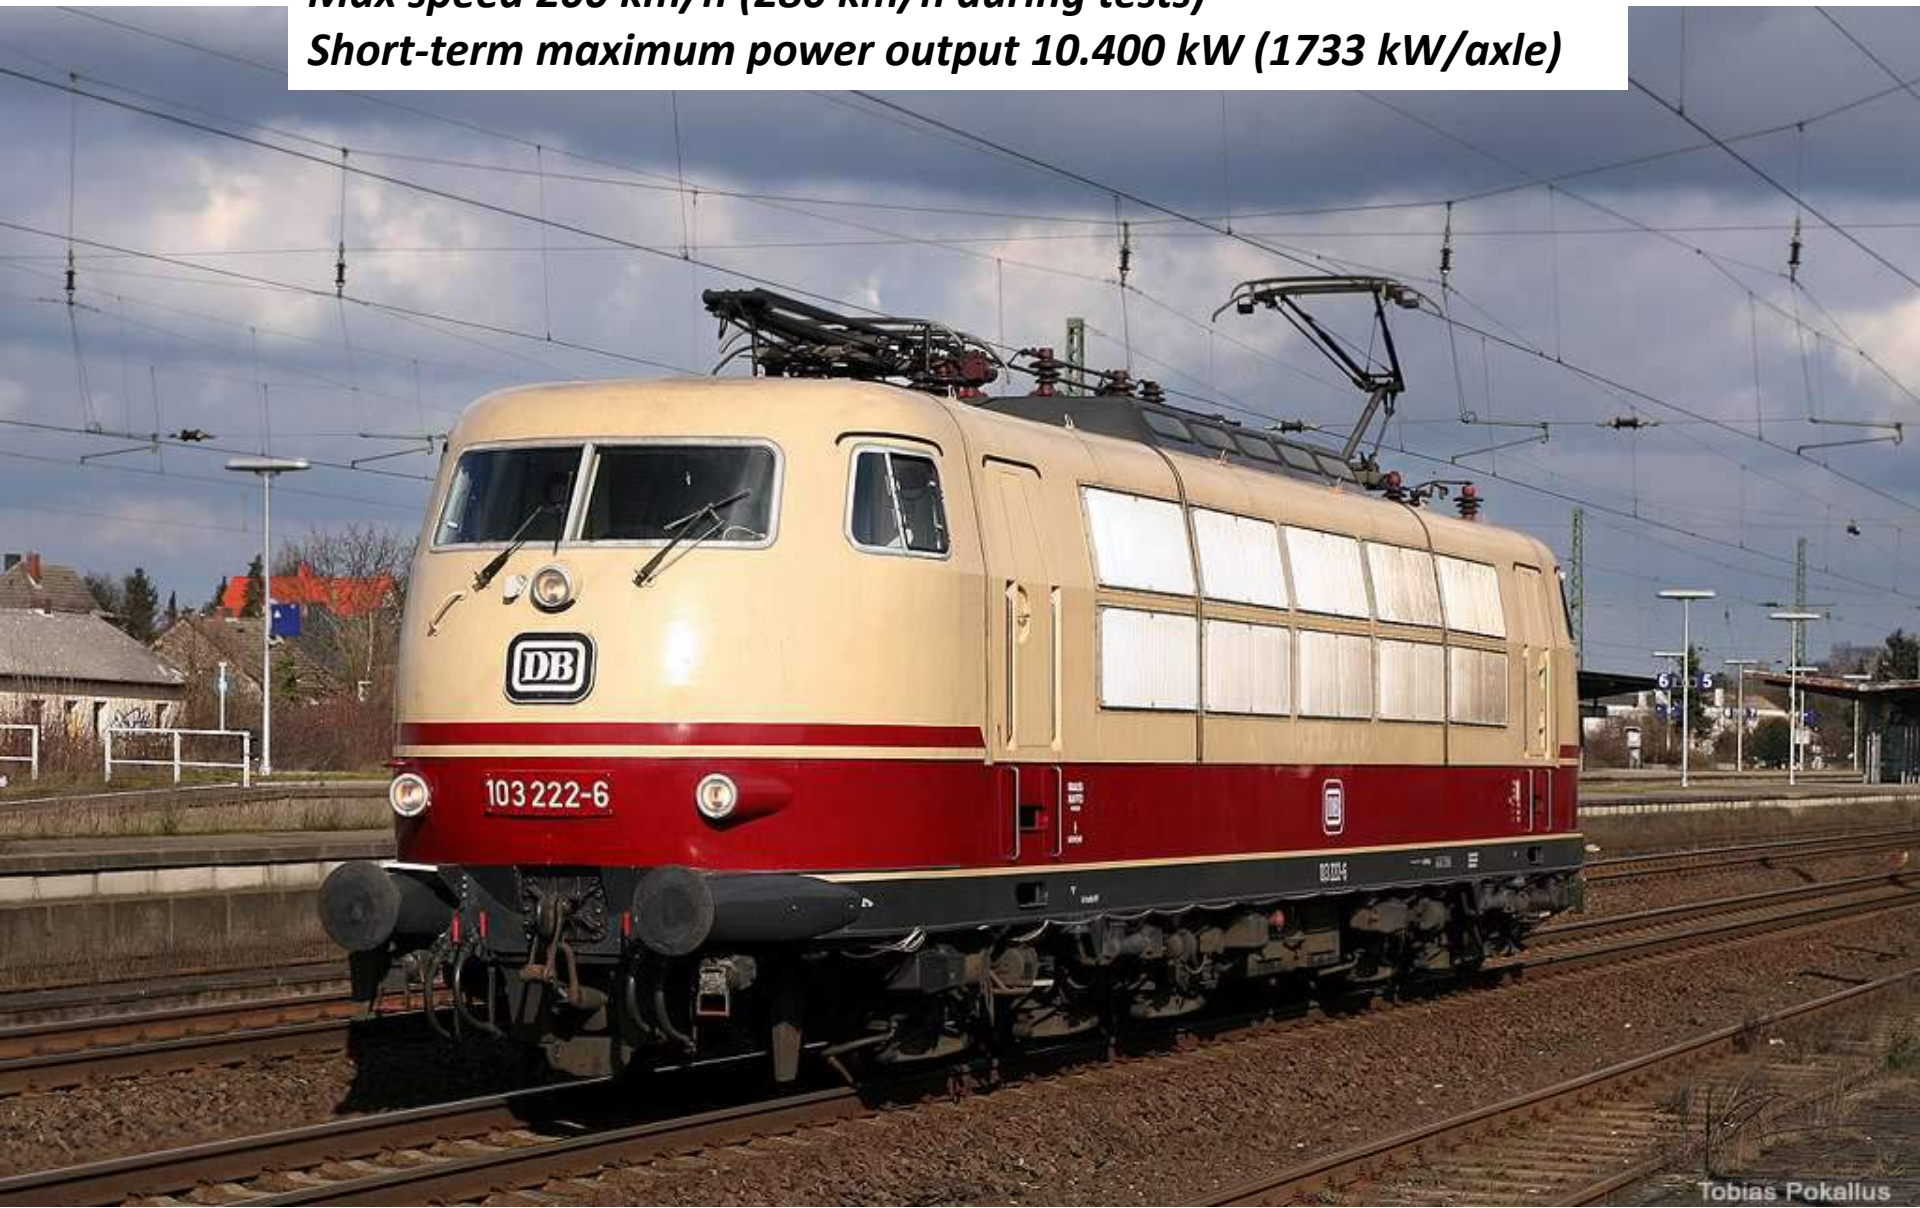
The Queen of German locomotives... DB E 03 (103)

Co'-Co' wheel arrangement

Max speed 200 km/h (280 km/h during tests)

Short-term maximum power output 10.400 kW (1733 kW/axle)

Incredibly, this locomotive had tired wheels

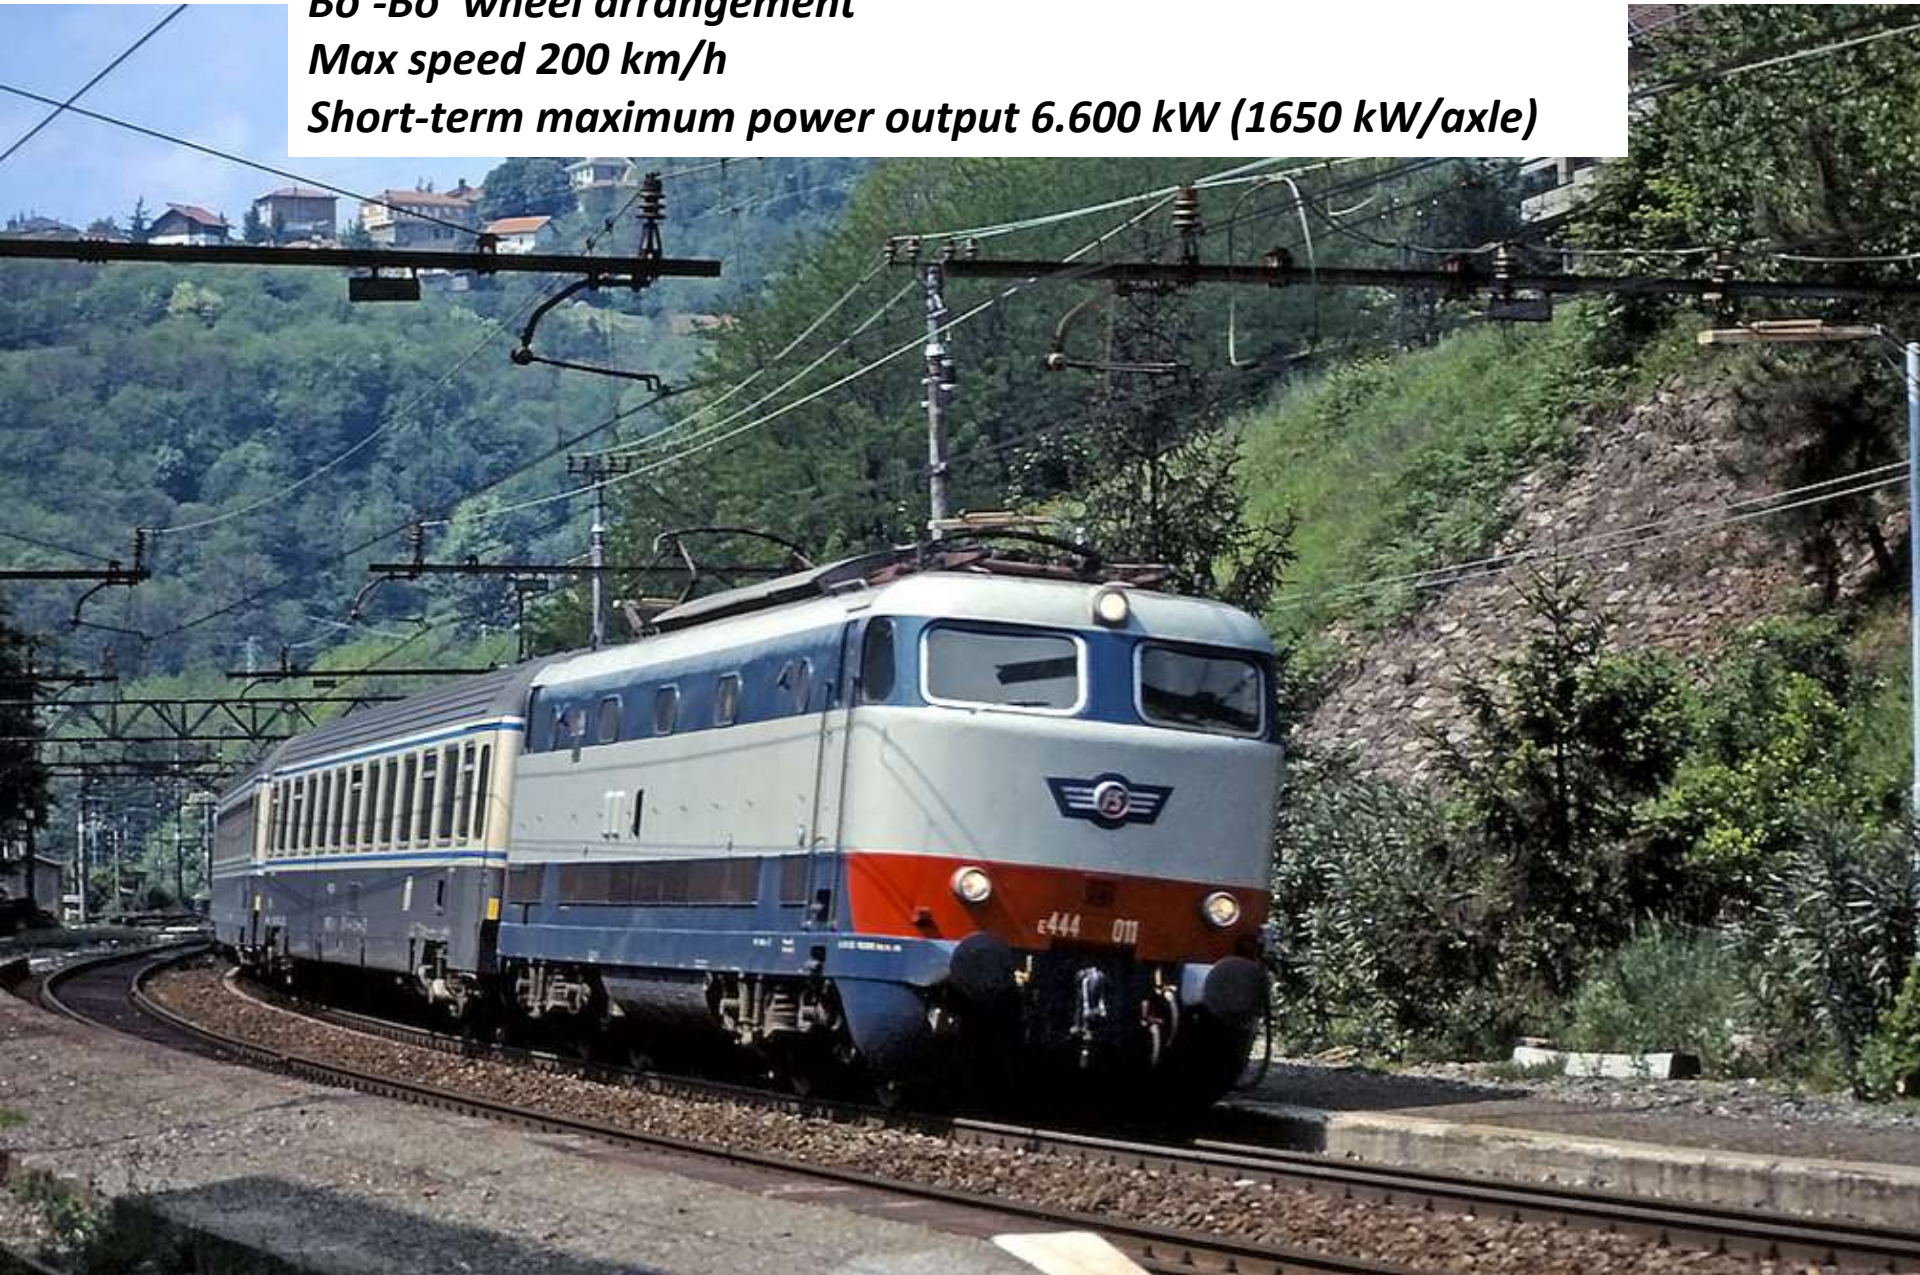
The Queen of Italian locomotives... FS E444

Bo'-Bo' wheel arrangement

Max speed 200 km/h

Short-term maximum power output 6.600 kW (1650 kW/axle)

Incredibly, this locomotive had tyred wheels

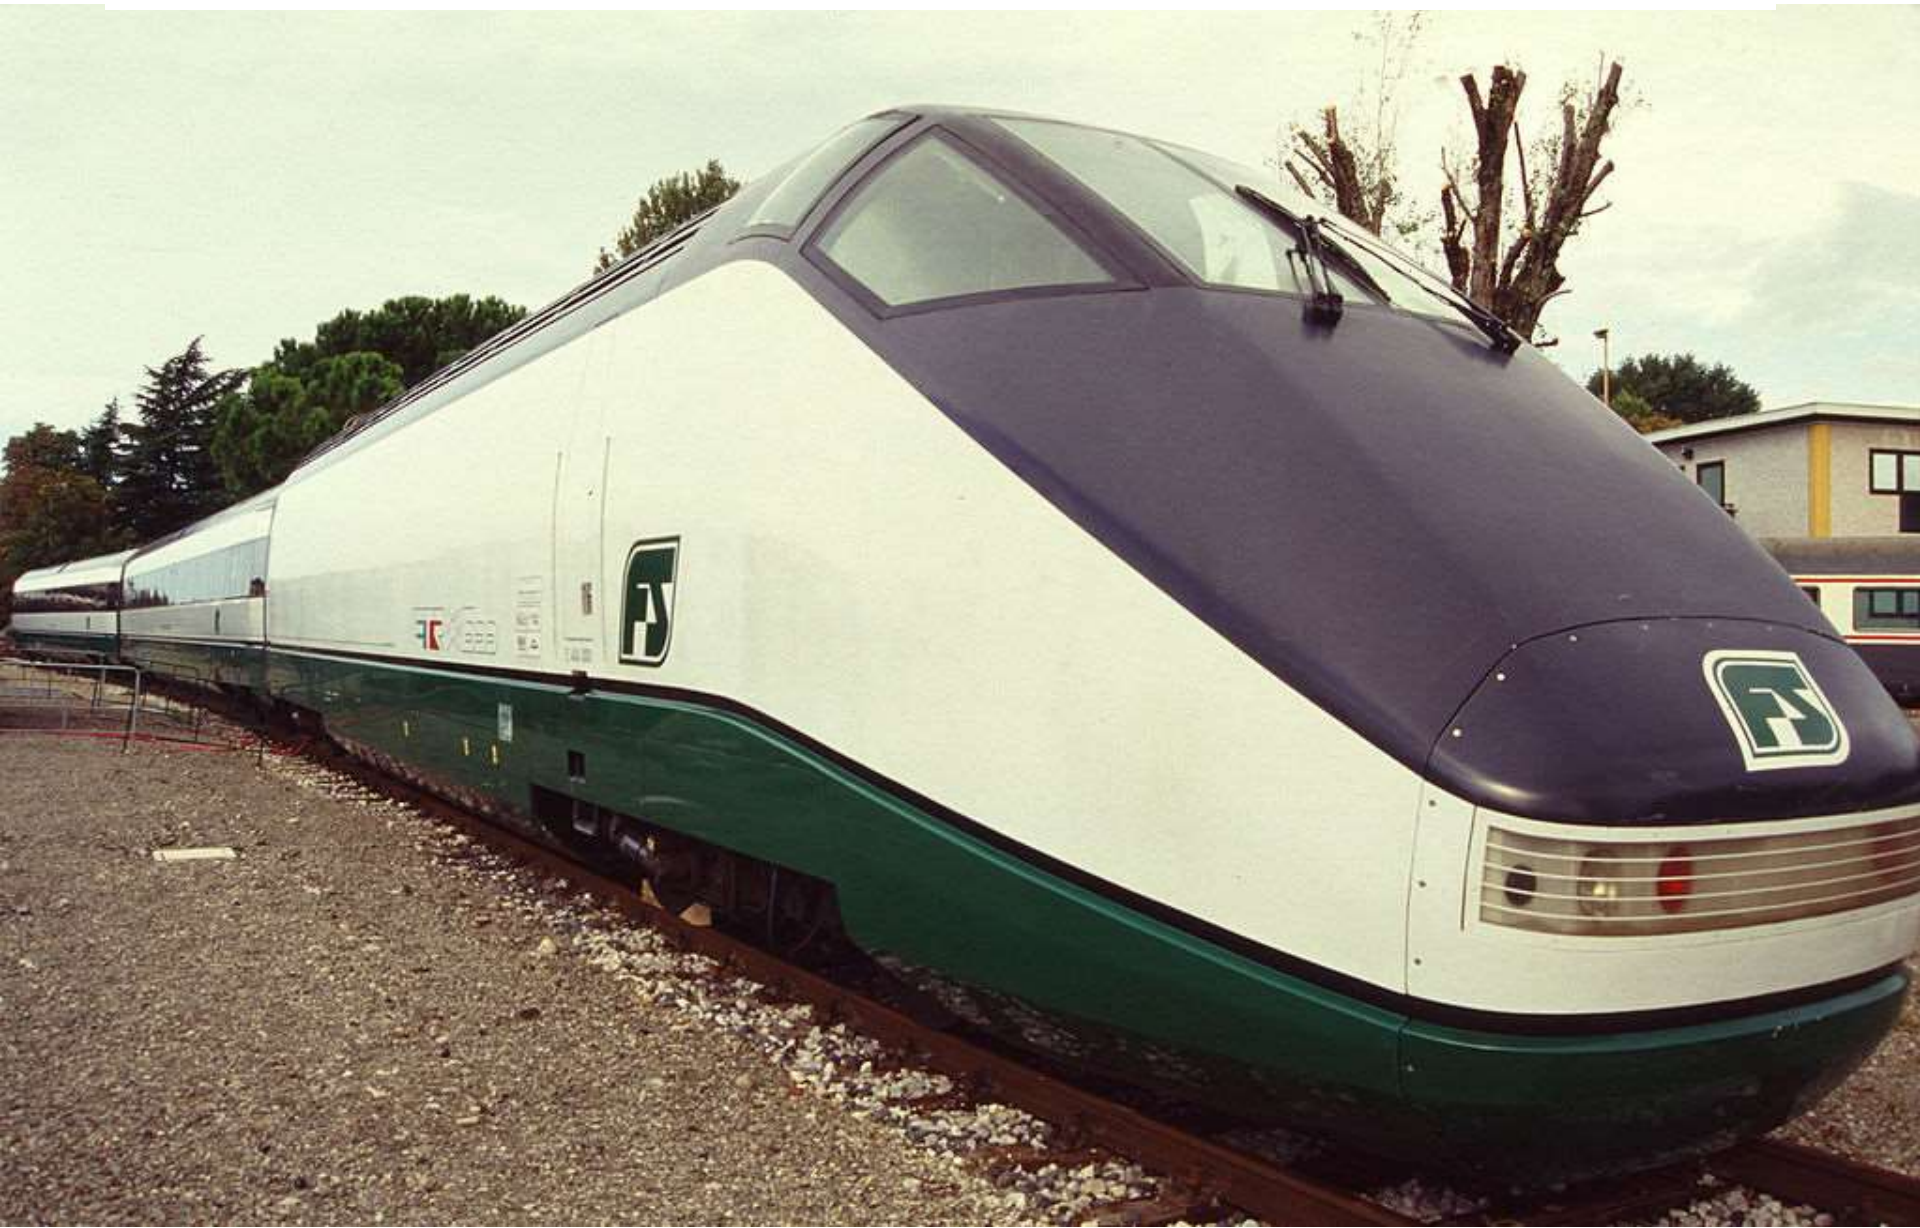
***But life goes on... and in Italy the future was represented at that time by ETR500
One loco (E404.000) and some coaches were produced for testing
On 25.5.1989, the ETRX500 train reached 316 km/h***

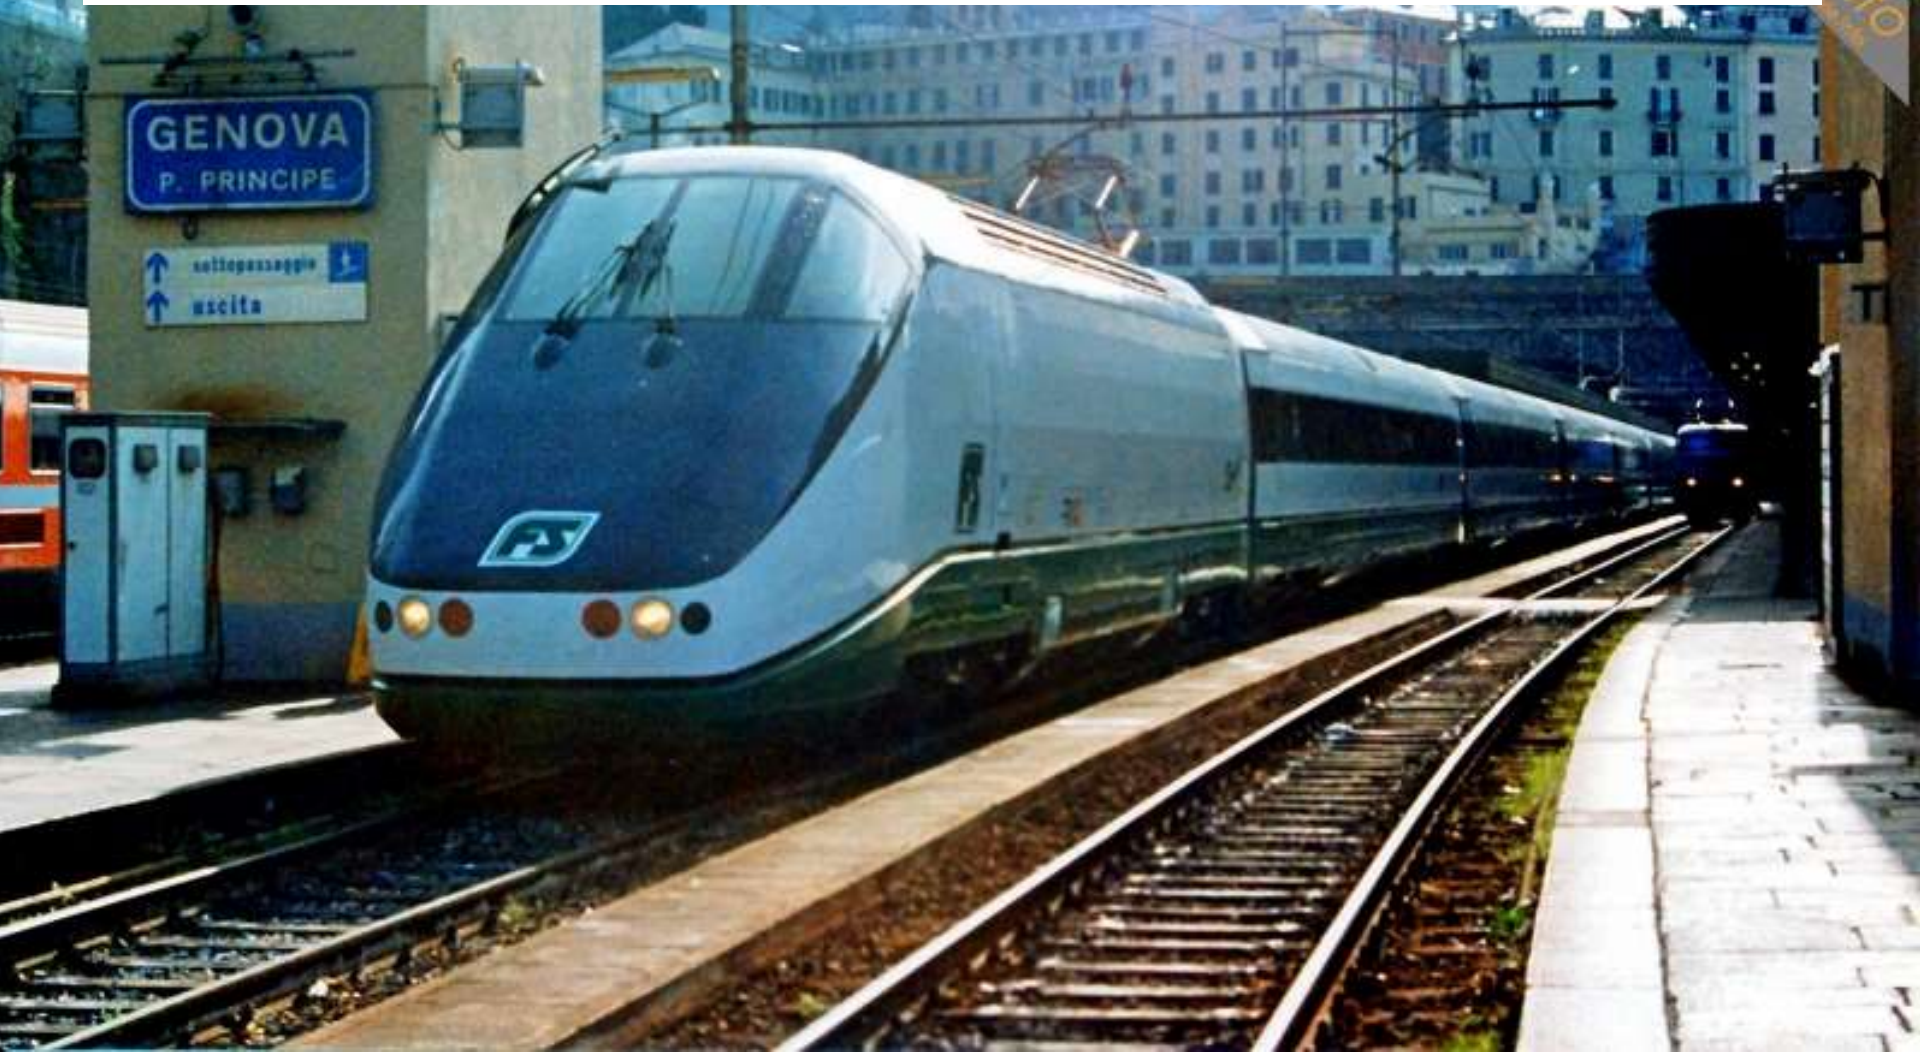
Two trainsets, called ETR Y 500, were put in service in 1990 for the football world championship

One of them reached 321 km/h in 1991, that represented the speed record in Italy until 3.2.2009 (362 km/h)

These two trains (with different locos) are still in service as diagnostic trains for RFI (ETR500 Y1 AIACE ed ETR500 Y2 DIA.MAN.TE.)

**All the locomotives (E404.000 and E404.001-004) had monobloc wheels.
Incredibly, all passenger coaches had tyred wheels.
Wheel centres had a corrugated web.**

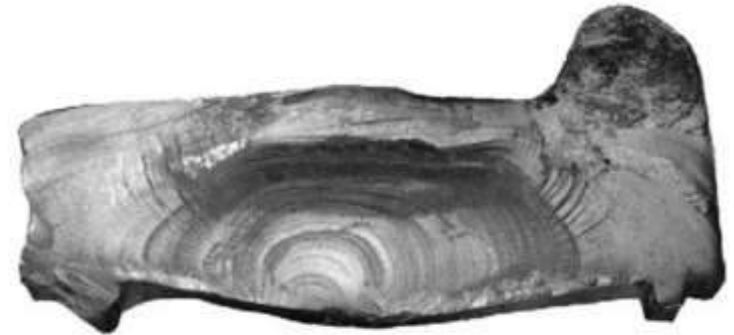
Fig. 4. Fracture surface of the broken wheel tire.

On the approximately 100 wheels which had been taken out of service before the accident no cracks or flaws have been reported when they were disassembled and scrapped. On the approximately 5000 remaining wheels removed after the accident several cracks were found in tires but no fractures. The cracks had occurred also in wheels with larger diameters than that of the accident and without pre-existing flaws. This supports the presumption of a rare or singular event which could have initiated the crack. It also supports the assumption of a generally quite low mean loading level because these cracks, which were detected later, had grown only very slowly or not at all and never reached a critical depth.

The nature of such a rare event can only be speculated about; in the official investigation of the case such topics were not brought up and because this wheel type is no longer used for high-speed trains no further research was done in this direction.

The case has shown as topics for improvement that modernisation of design rules or international standards is necessary, that realistic measurement of service loads and impact factors should be carried out previous to design work, that the weak spots need identification by tests on roller type test stands until fracture and nondestructive test of these weak spots ought to be done in the regular service checks.
